Large Tank Fire

Thailand

December 1999

Flammable Liquids Filling Operation

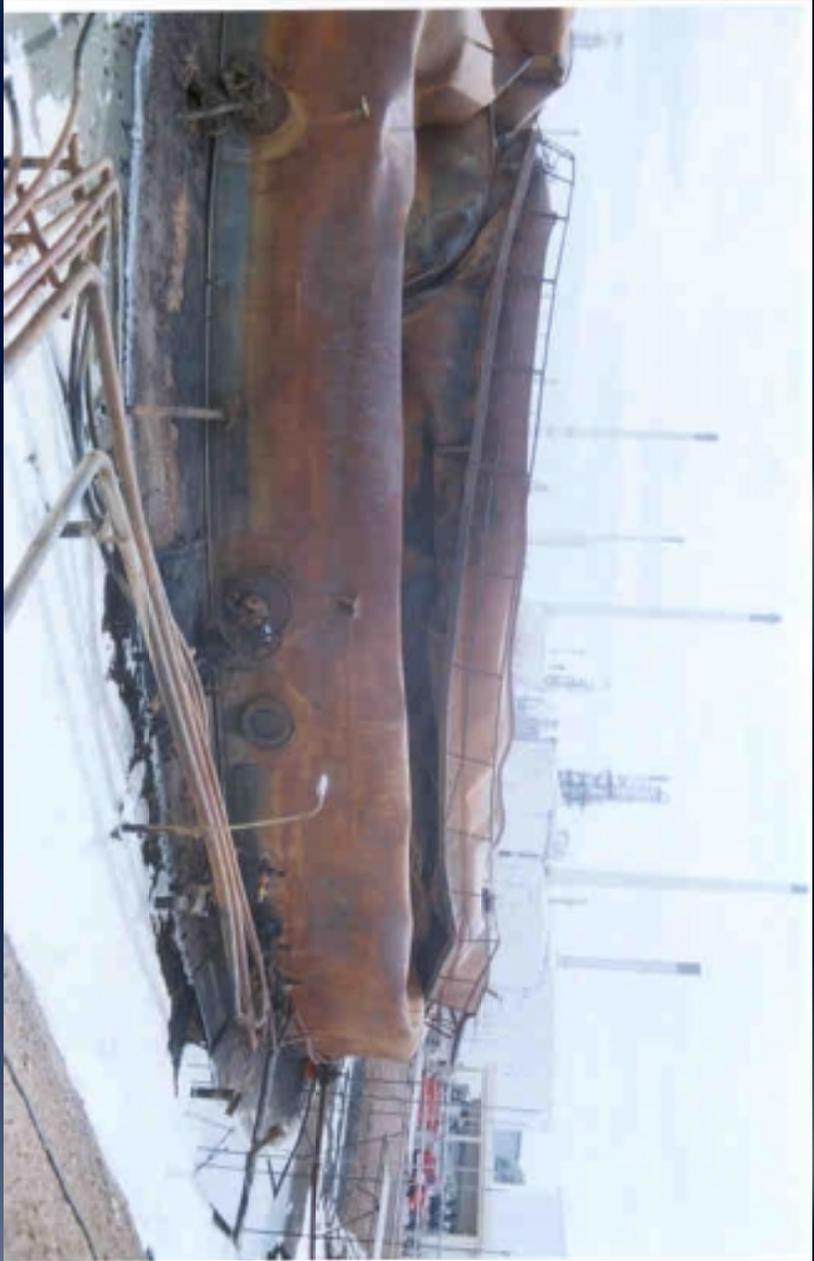
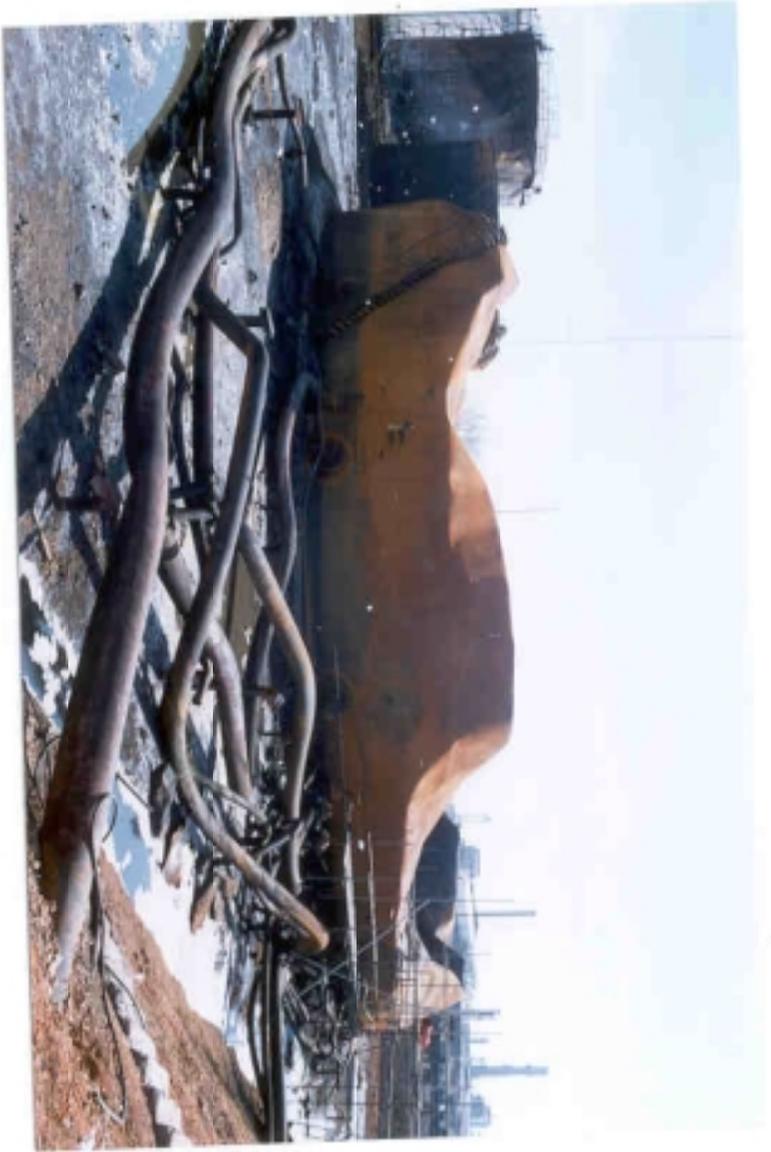
- **7 staff/contractors were killed**
- **Fire damage was largely confined to 5 of the 9 tanks within the dike (#3004, 3005, 3006,3003 & 3022)-all destroyed, along with 41 million liters of gasoline**
- **Two other tanks within the dike were less seriously damaged (#3058 & 3036)**
- **Fire damage to piperack traversing the diked area**

- **Blast damage was more widespread:**
 - Walls of several tanks facing the blast were rippled (tanks T113 to T126)
 - Main office/administration building
 - Warehouses #1 & #2
 - Fire station & six fire trucks parked inside
- **No damage to process units however site was shutdown in a controlled manner**

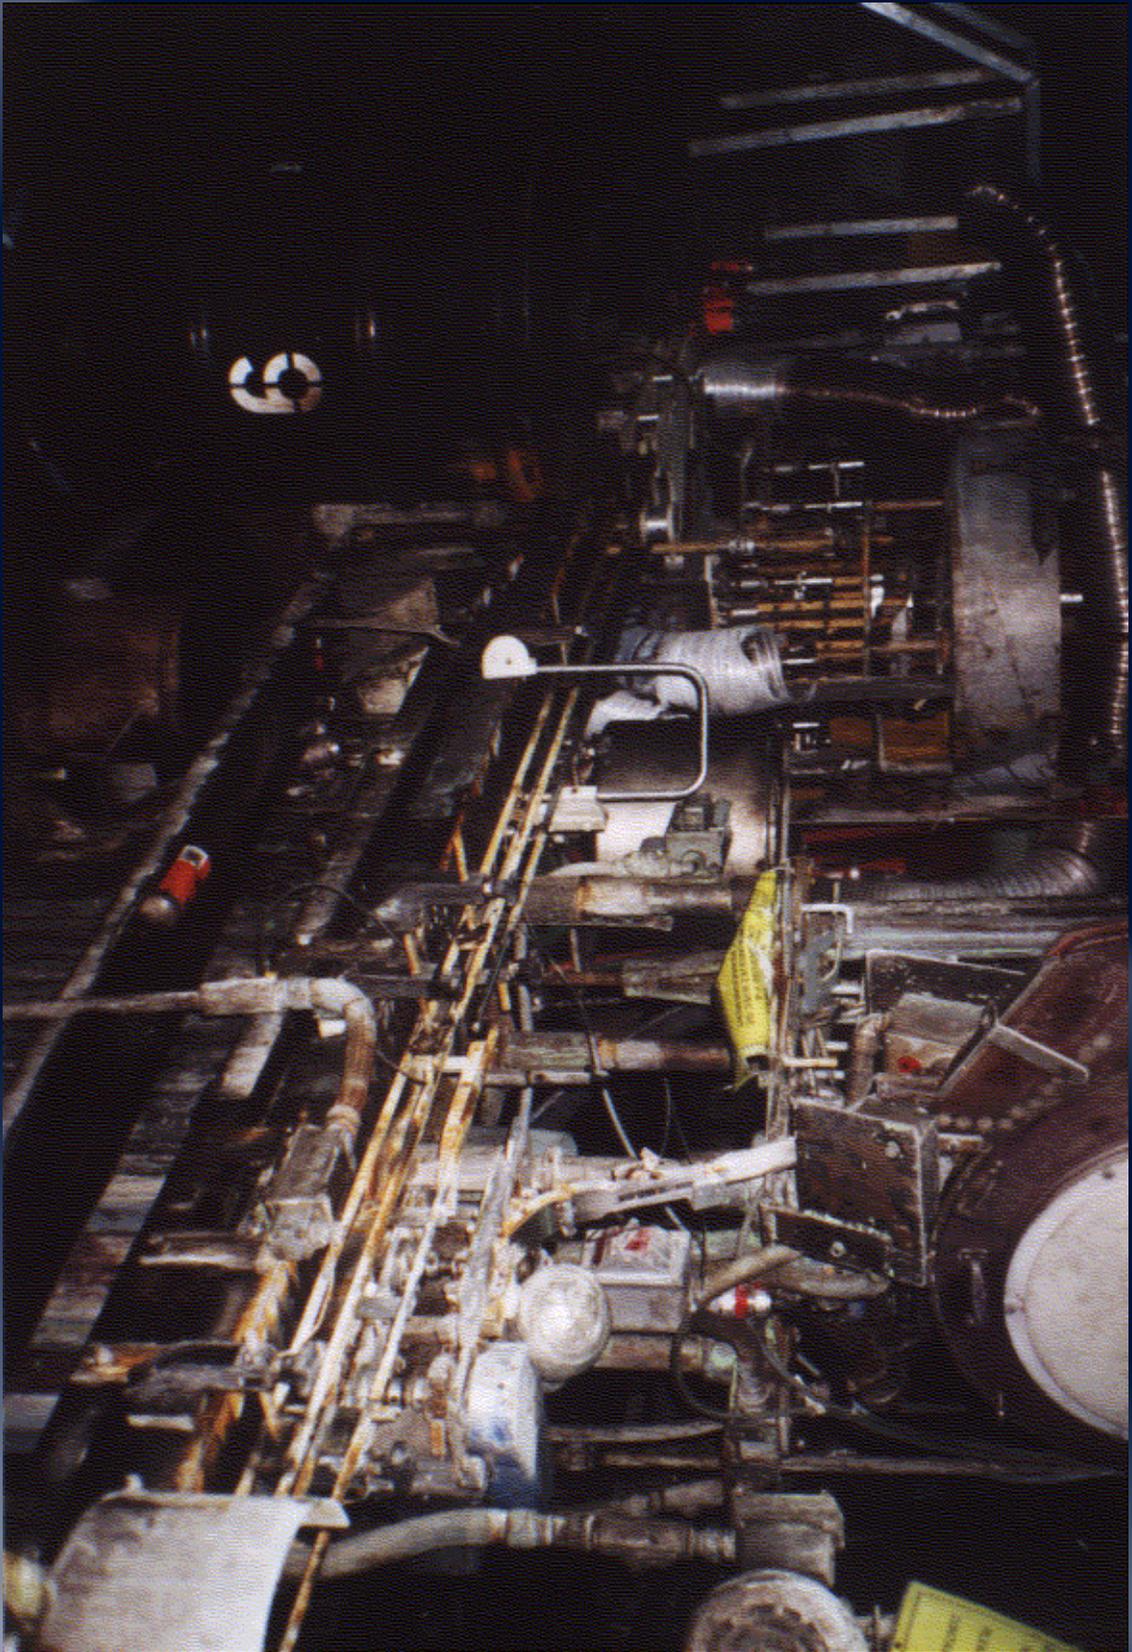
- ★ **2 employees receive minor injuries**
- ★ **Fire fighting**
 - **Eleven of 18 sprinkler heads within the filling area fused and operated.**
 - **Five sprinkler heads outside the filling area and below the bottle nets also fused and operated.**
 - **Ten, 20A-10BC and five, 10A-5BC fire extinguishers were used.**
 - **3400 US gallons of foam/water were treated on-site.**

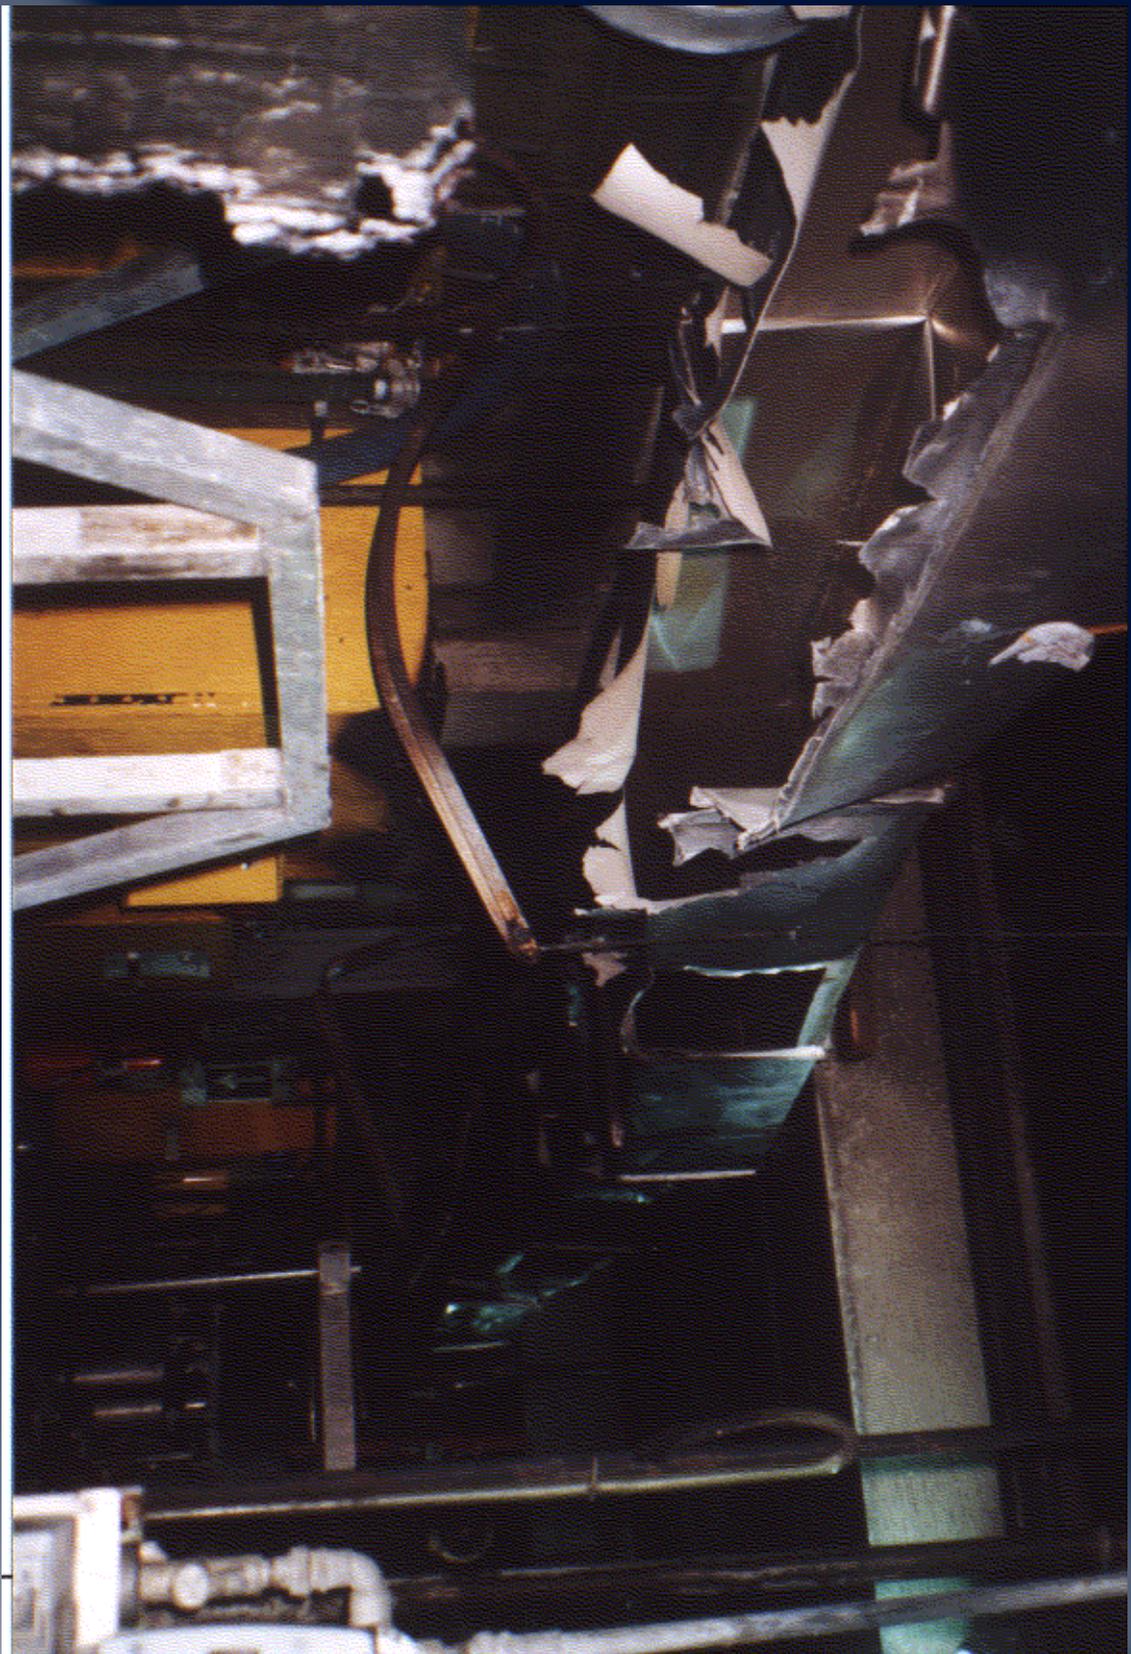
- Severe heat damage to filling lines 3 & 4
- Severe heat damage to the ventilation system
- Heat damage to all electrical equipment
- Moderate to light smoke and water damage to filling lines 1, 2, 5, 6 & 7
- Moderate smoke damage to the entire area

- ★ **Mezzanine above filling area.**
 - Severe heat damage to bottle nets and associated conveyor system
 - Water damage to production equipment
 - Light smoke damage to production equipment
- ★ **Labeling area**
 - Heat damage to entire area
- ★ **Packaging & storage areas**
 - Light to moderate smoke damage

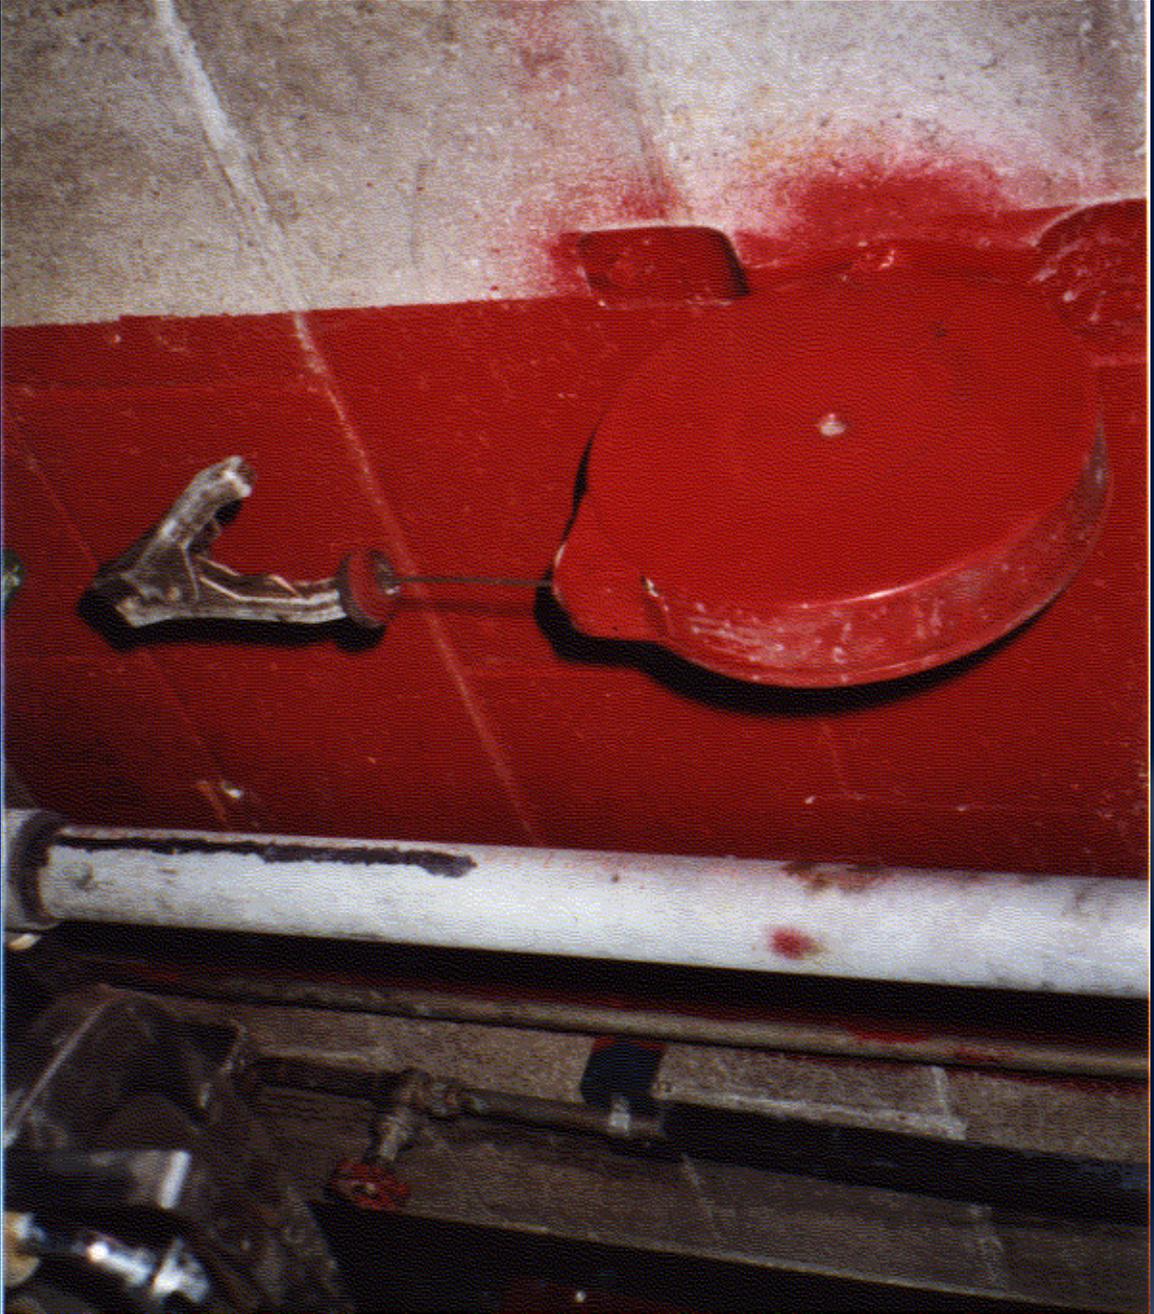
- ★ **Static charge from the splashing of lacquer thinner into a 45 gallon metal drum.**
 - **Less than 10 gallons of lacquer thinner within the collecting drum**
 - **Less than 130 US gallons of various flammable liquids were involved in total (includes other filling lines)**

- ★ Reinforce use of safe grounding & bonding procedures.
- ★ Install fire rated dampers on filling room ventilation system.
