Lessons Learned from an Unusual Hydrogen Reformer Furnace Failure

T. M. Rogers

Syncrude Canada Limited

- Within the Upgrading plant 300 MSCFD of hydrogen in three steam/ methane reformers is produced
- The incident occurred in the reformer furnace of unit 3

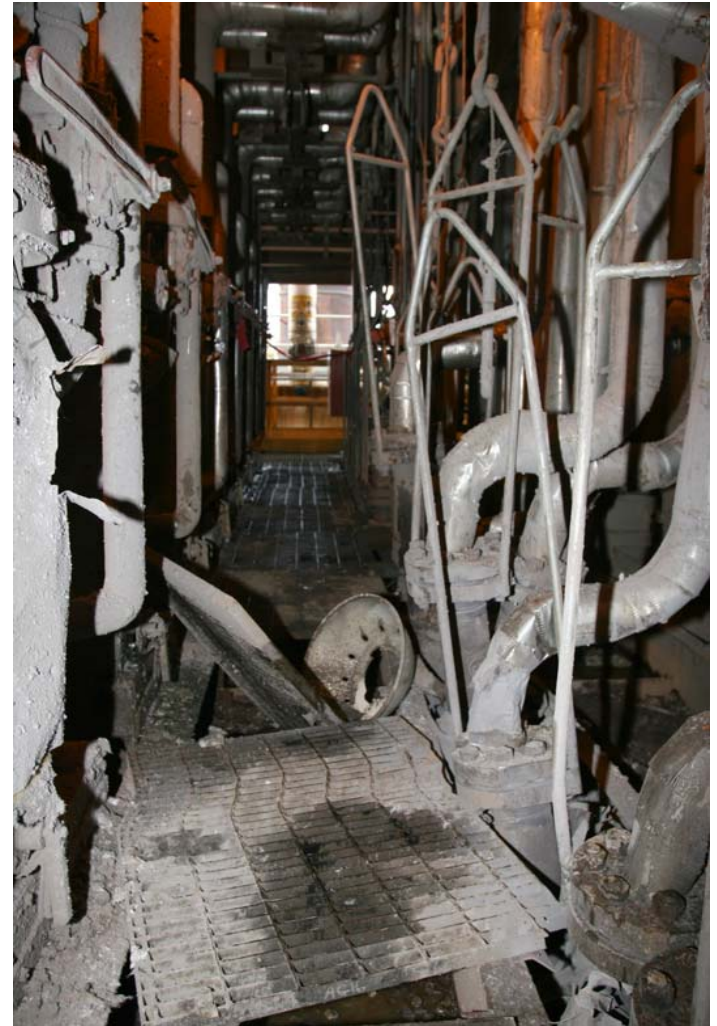
- **41 more tubes were destroyed as a result of impacts by tube segments and the subsequent shock wave**
- **All of the flue gas tunnels suffered extensive damage**
- **Fire box sustained impact damage from shrapnel hits**
- **One Operator sustained serious injuries when he was hit by one of the ejected tube assemblies**
- **The entire reformer section was condemned necessitating replacement**

Post Incident External Damage

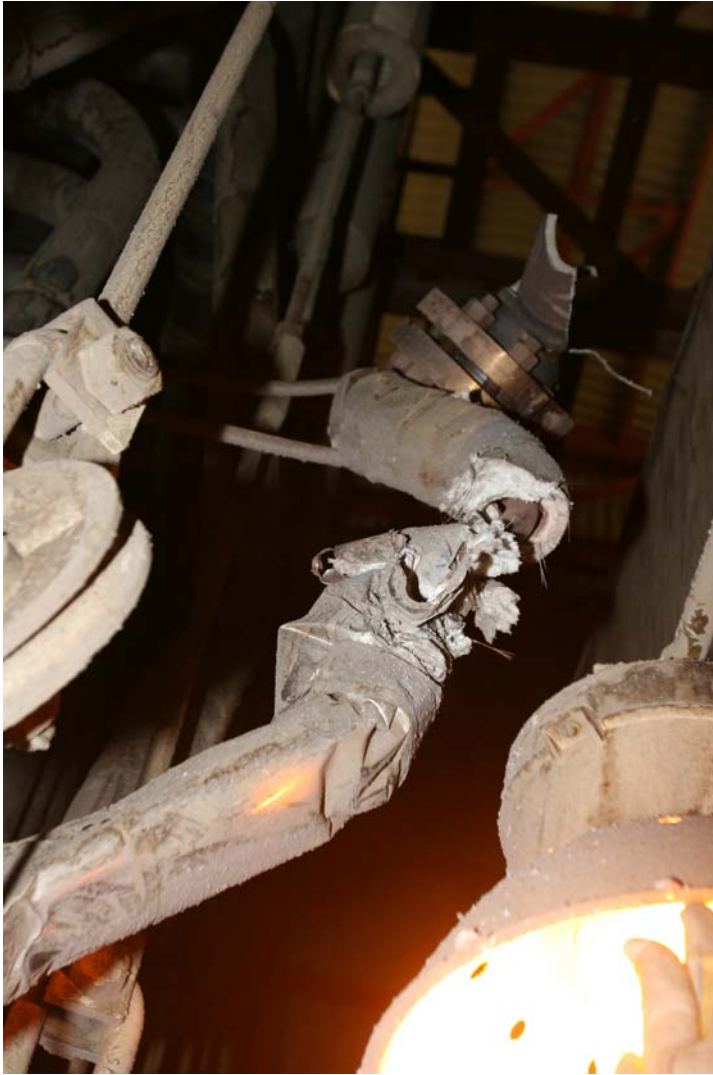
**Tube 161 lifted approximately
16 ft (view looking up)**

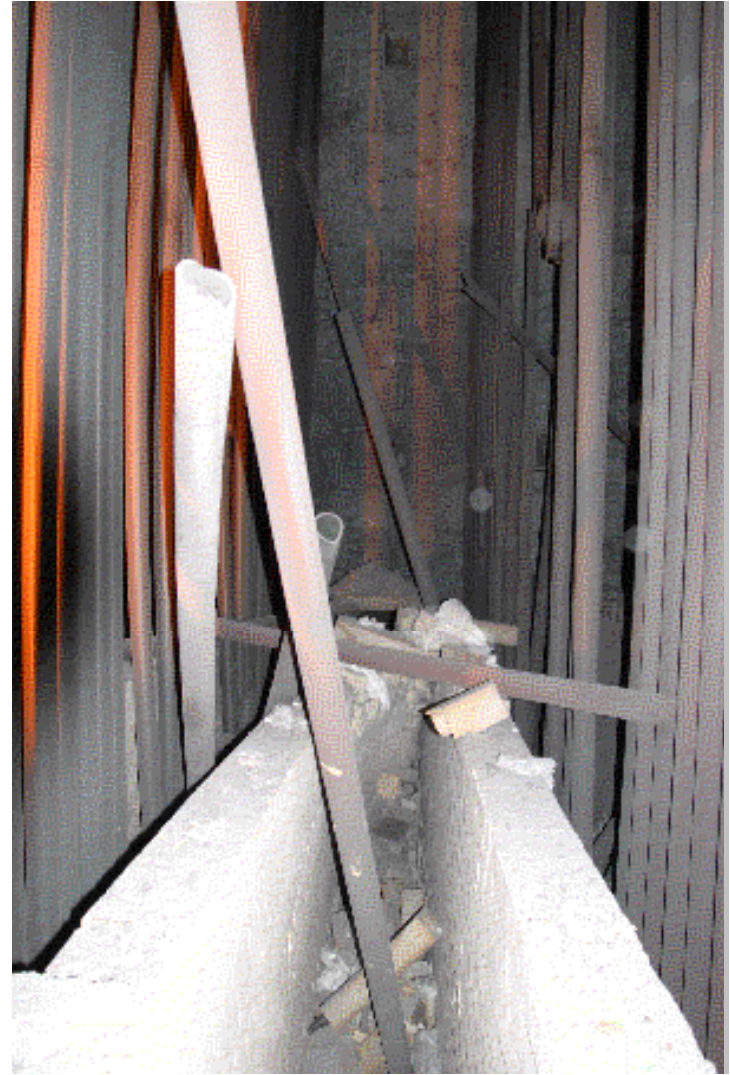
Internal condition of radiant section

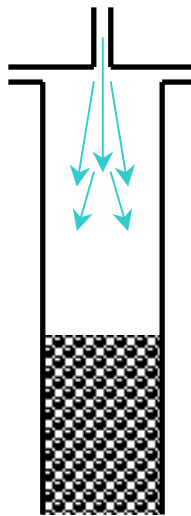
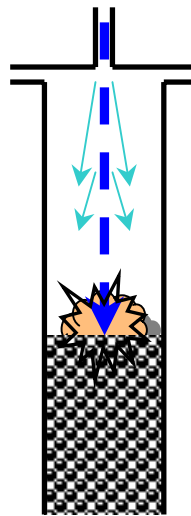
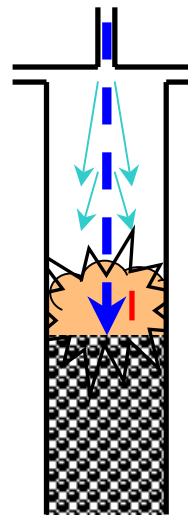
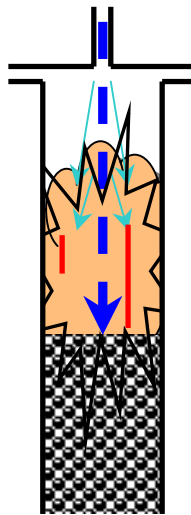
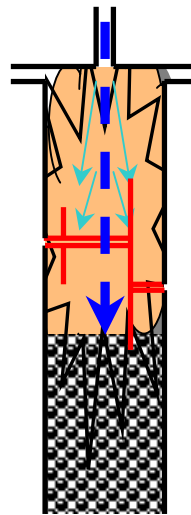
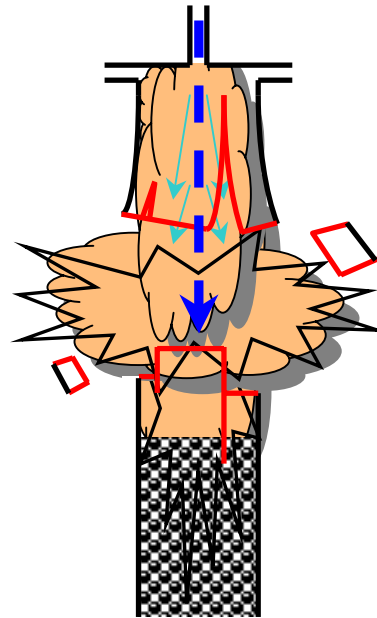
- **Prior to start-up water was present in the feed system upstream of the radiant tube section**
- **As the Process Steam flow was ramped up per the startup procedure (increased mass and velocity) it picked up water and carried it into the radiant tubes**
- **Water introduced into tubes underwent an rapid phase change generating an extreme local pressure impulse and shock wave. The wave initiated longitudinal cracking**
 - **Entrained water impinged on hot (350°C) catalyst and possibly the pipe wall, "instantly flashing"**
