# Implications of Feed Contamination on the Integrity of An Operating Plant - An Accident Case Study

Brian D. Kelly P.Eng., MCIC  
Syncrude Canada Ltd.  
Fort McMurray, AB T9H 3L1

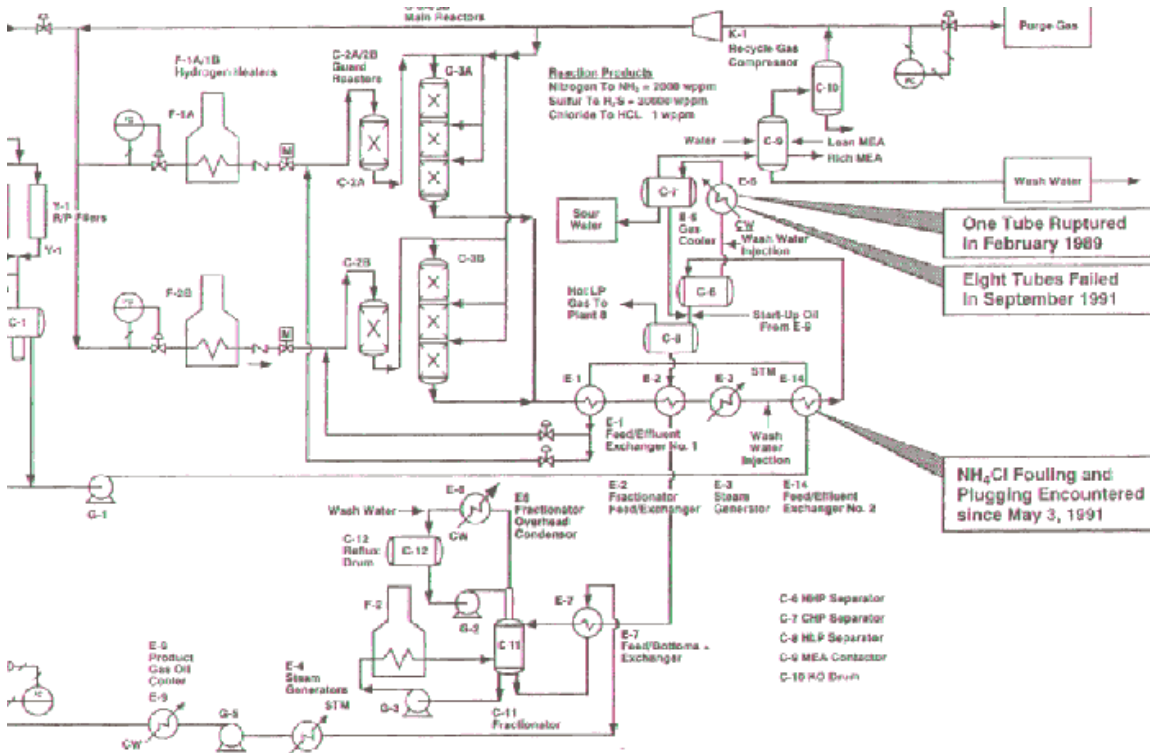
Figure 2. Process Sketch Identifying Failure

From this point, the investigation focused its efforts almost entirely on the physical damage associated with the initiating failure in the exchanger. In addition to a severely distorted alloy bundle, nine one inch tubes appeared to have failed simultaneously. The failures were all in close proximity to one another. Such a failure mode is highly inconceivable. Mechanical equipment always fails at a single point as

While the prime effort continued on the exchanger, some technical resources were assigned to examine the cooling tower and the cooling water return line. Hazard modeling (fire and explosion) was used to reconcile the physical damage to the total energy released in the incident. It was soon evident that a large volume release had occurred, well in excess of that which could pass through a break in a one inch pipe. Light vapor in the large water lines caused severe cavitation and water hammer and destroyed the return bend on the inlet headers of the cooling tower. The electric fans on the cooling tower were a probable source of ignition and likely caused the vapor to explode. The explosions damaged the wooden slats on two of the cells.

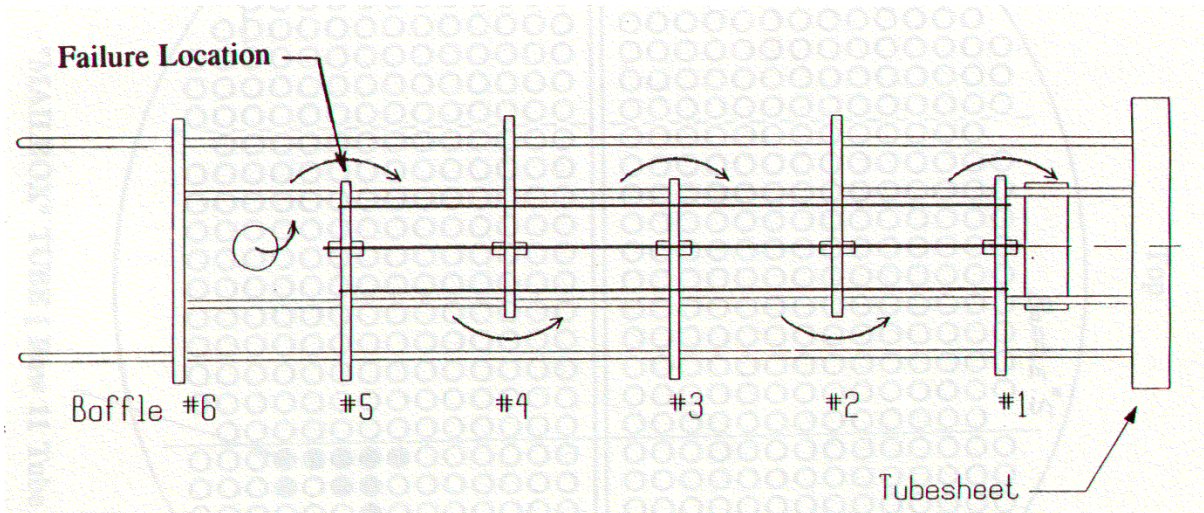
Figure 3. Bundle Flow Configuration

It was ultimately determined that two changes highlighted above acted together to produce a relatively high concentration of inorganic chloride within the exchanger tubes. The wash water along the bottom of the tubes was sufficient in quantity to dilute the chloride and remove it from the tubes. This was not the case in the upper portion of the tubes. Corrosion cracking progressed until a single point failure occurred. This failure was assisted by vibration in the vicinity of the tubesheet.

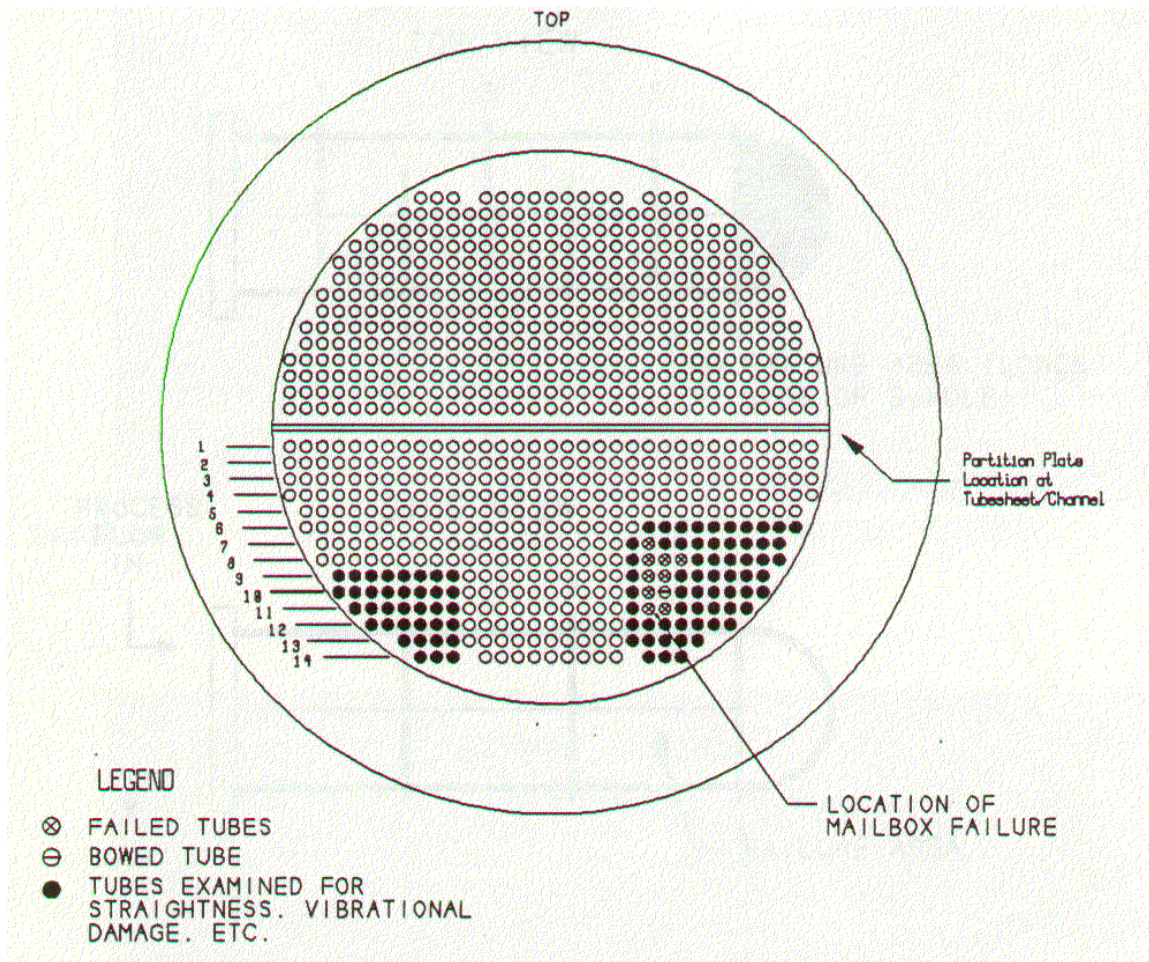
Figure 4. Pattern of Tube Damage in Failed Bundle

The heat exchanger bundle that failed had been in service for five years. Close examination of all tubes in the bundle revealed acute localized thinning at the top of the tubes near the tubesheet. Finally, it was determined that one tube had a unique type of fracture. It had split longitudinally for approximately 3 inches and the metal had bent outwards resembling a mailbox. It was speculated that because of the high pressure of release the cutting action of hydrogen and associated vibration simply caused the remaining tubes to fail. Ultimately, this process would continue till some form of equilibrium was reached. The multiple tube failure was in reality a two event failure separated by perhaps as much as seven minutes. Although the rupture disc did release to atmosphere, most of the discharge traveled down the cooling water circuit and was released into the cooling tower.

A detailed metallurgical examination was conducted of all the tubes in the ruptured bundle. Tube ID measurements taken randomly 6" from the tubesheet and compared with readings from a previous inspection suggested potential metal loss of 40 thousandths of an inch in one calendar year. At this rate of loss, it was not considered safe to simply repair the damaged exchanger and return it to service. The mystery partly solved, the question became "how and why did the exchanger bundle suddenly experience dramatic metal loss along the top inside diameter?". What had changed? The principal operating parameters had remained constant since 1985. A modified shutdown procedure involving less steam allowed collection of solids at the far end of the exchanger bank. These solids contained 28% chloride and 11.8% ammonia. While ammonia is a normal byproduct of hydrotreating, chloride is not. In fact, chloride is a foreign species in any oil refining operation and is responsible for the destruction of costly alloy metals via a mechanism known as chloride stress corrosion cracking.

1. The bundles of the recycle gas coolers were replaced with new bundles fabricated from Inconel. This alloy is highly resistant to attack from chlorides at a wide range of concentrations. Plans were made to shutdown the other hydrotreaters and install similar metallurgy in critical exchangers.

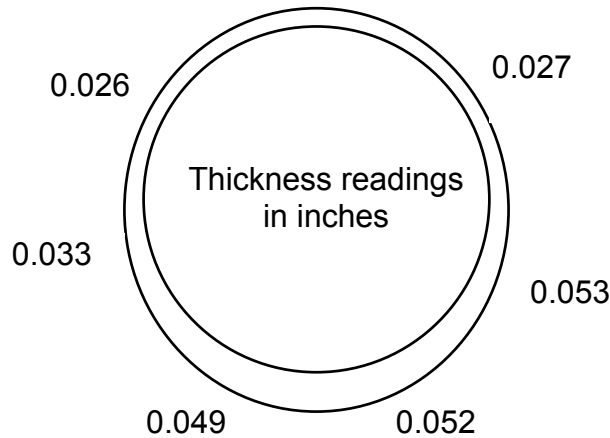
Figure 5. Cross Section of Corroded Tubes

The metallurgical analysis revealed the failure to be the result of ammonium chloride corrosion to the inner surface of the tubes. The chloride acted both as a poison in the liquid phase to debond the iron sulfide scale, and as a corrosive medium in areas beneath the hydrolysed ammonium chloride deposit. The exchanger tubes had been

embrittled as evidenced by a 33% drop in ductility from the specified minimum for the Sandvik alloy. The initiating mailbox failure originated from a small corrosion defect at the highest stress location (thinnest wall) portion of the tube. There was no evidence of stress corrosion cracking.

Corrosion fatigue is a result of simultaneous action of cyclic stresses and chemical attack. Cyclic stresses also include the effects of vibrational loading. Hydrolysed ammonium chloride produces hydrochloric acid underneath the deposit which produces pitting of metal surfaces. The pits act as notches which reduce the fatigue strength of the material. When corrosion attack occurs simultaneously with fatigue loading, a pronounced reduction in fatigue properties results which is greater than that produced by prior corrosion of the surface. As a result, when corrosion and fatigue occur simultaneously, the chemical attack greatly accelerates the rate at which the crack propagates.
